Water Quality Monitoring in the Vicinity of Lake Laura (2010-2013)

1. Executive Summary

3. Water Quality Sampling and Analysis

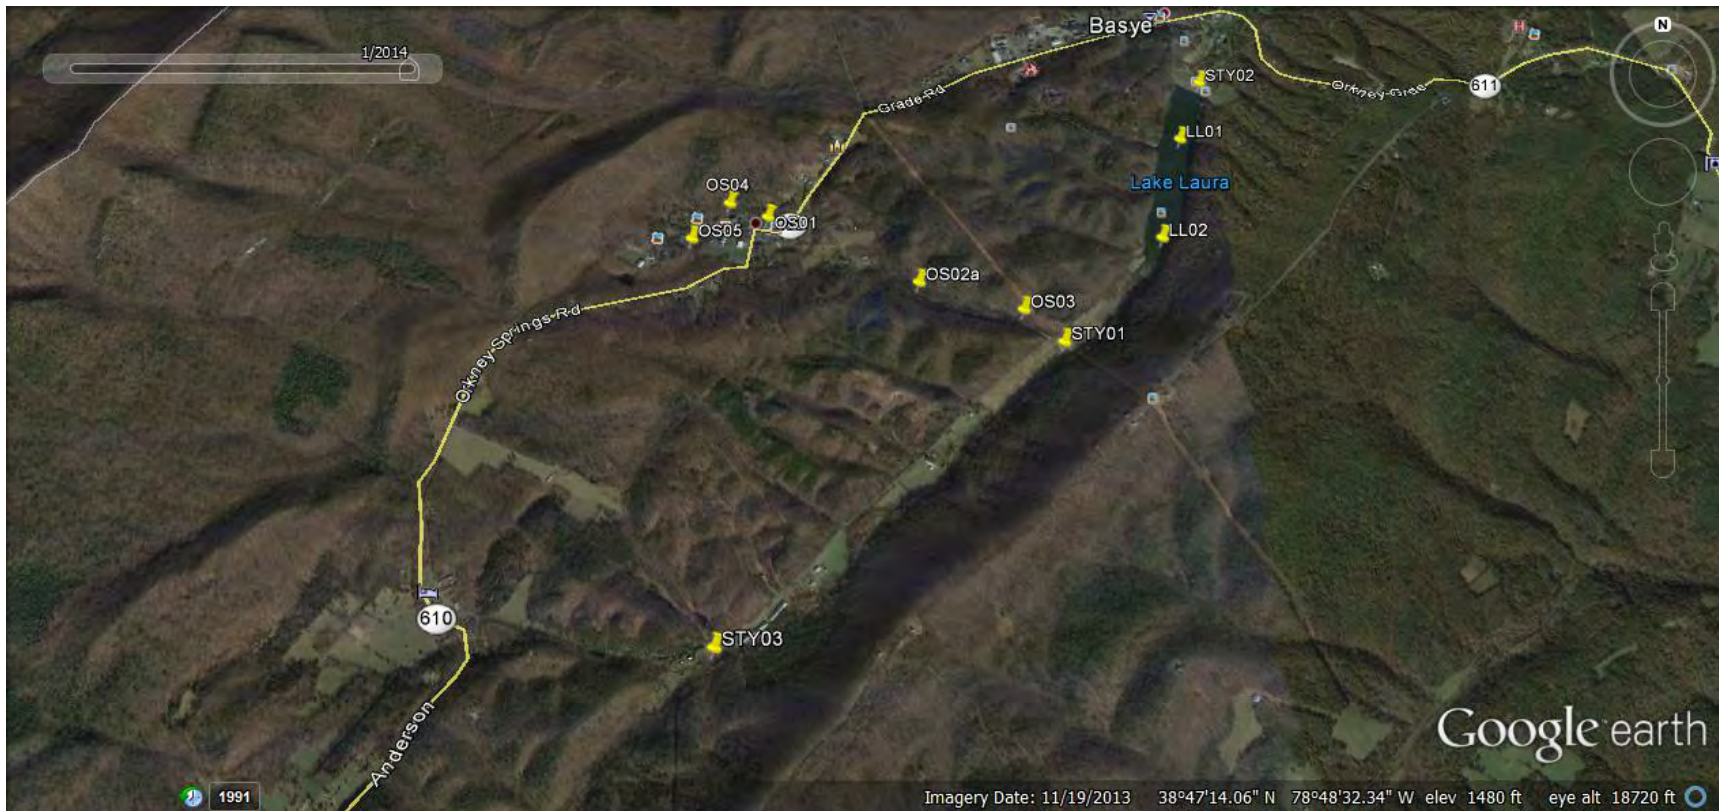
Figure 3-1 Location of Sampling Sites at Lake Laura

During this study, water samples were taken above, below and in the lake. Samples were collected and analyzed for the unnamed tributary associated with Orkney Springs (which flows into Stoney Creek above the lake), Stoney Creek above the lake, the lake itself, and Stoney Creek where it reforms below the dam. Table 3-1 lists the sampling sites during the project. It is followed by a map showing their locations.

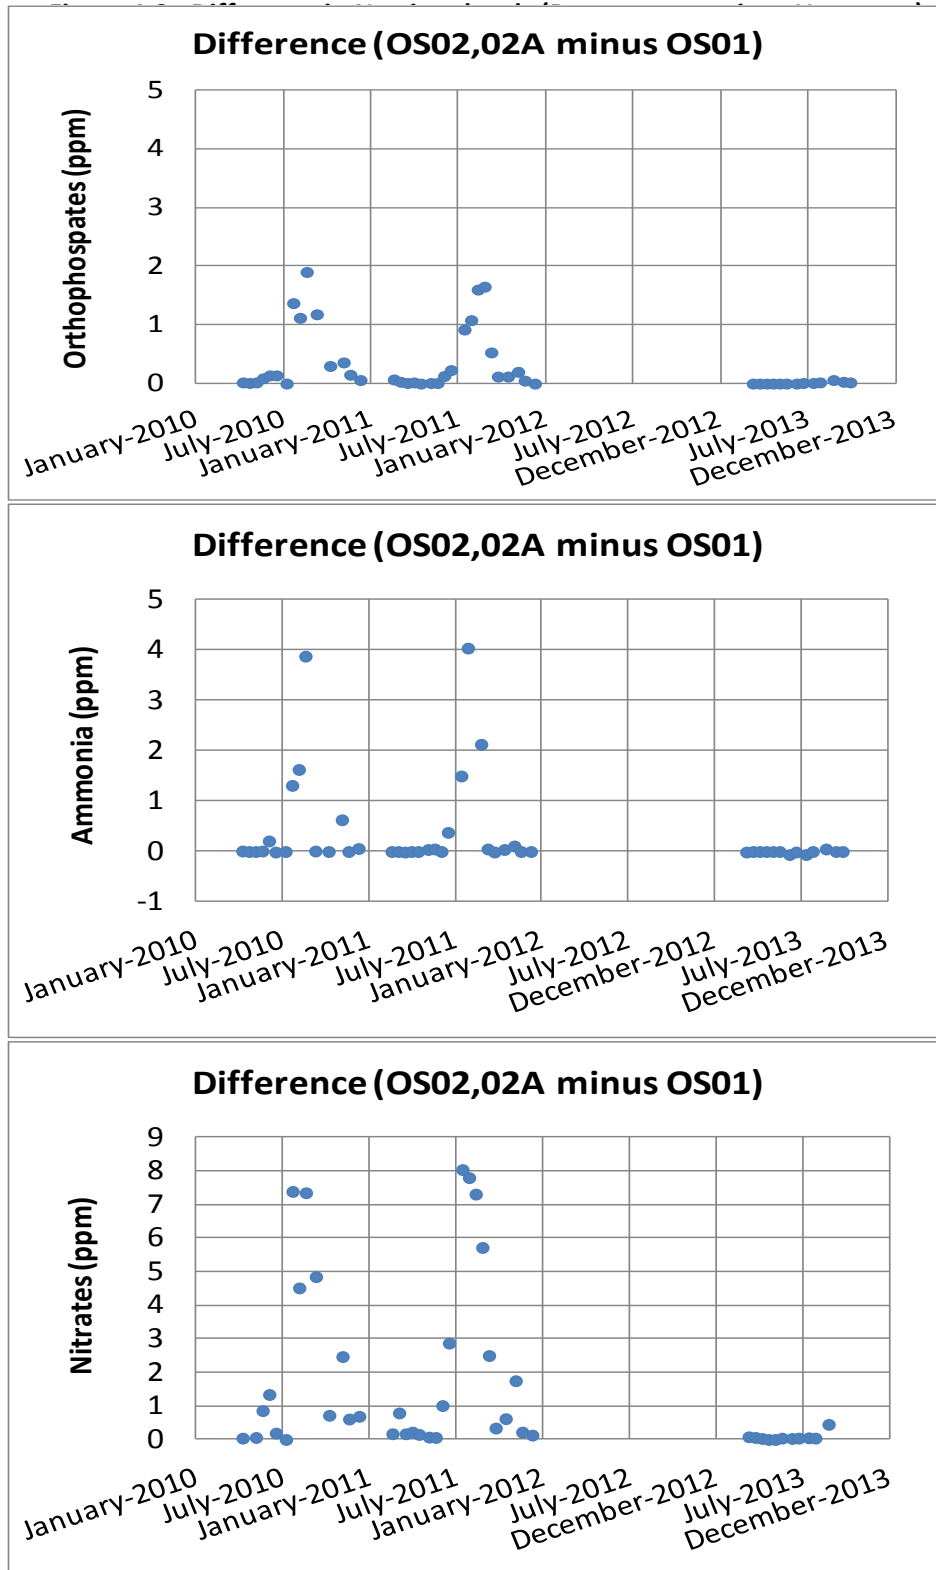
The same comparison for nutrients is very different. Figure 4-2 shows that the nutrient loading was much higher downstream when the Orkney Springs wastewater plant was operating in summer months. After the Orkney Springs wastewater discharge was eliminated, there is no discernible difference between the upstream and downstream readings. This indicates that the Orkney Springs wastewater discharge had been a significant source of nutrients.

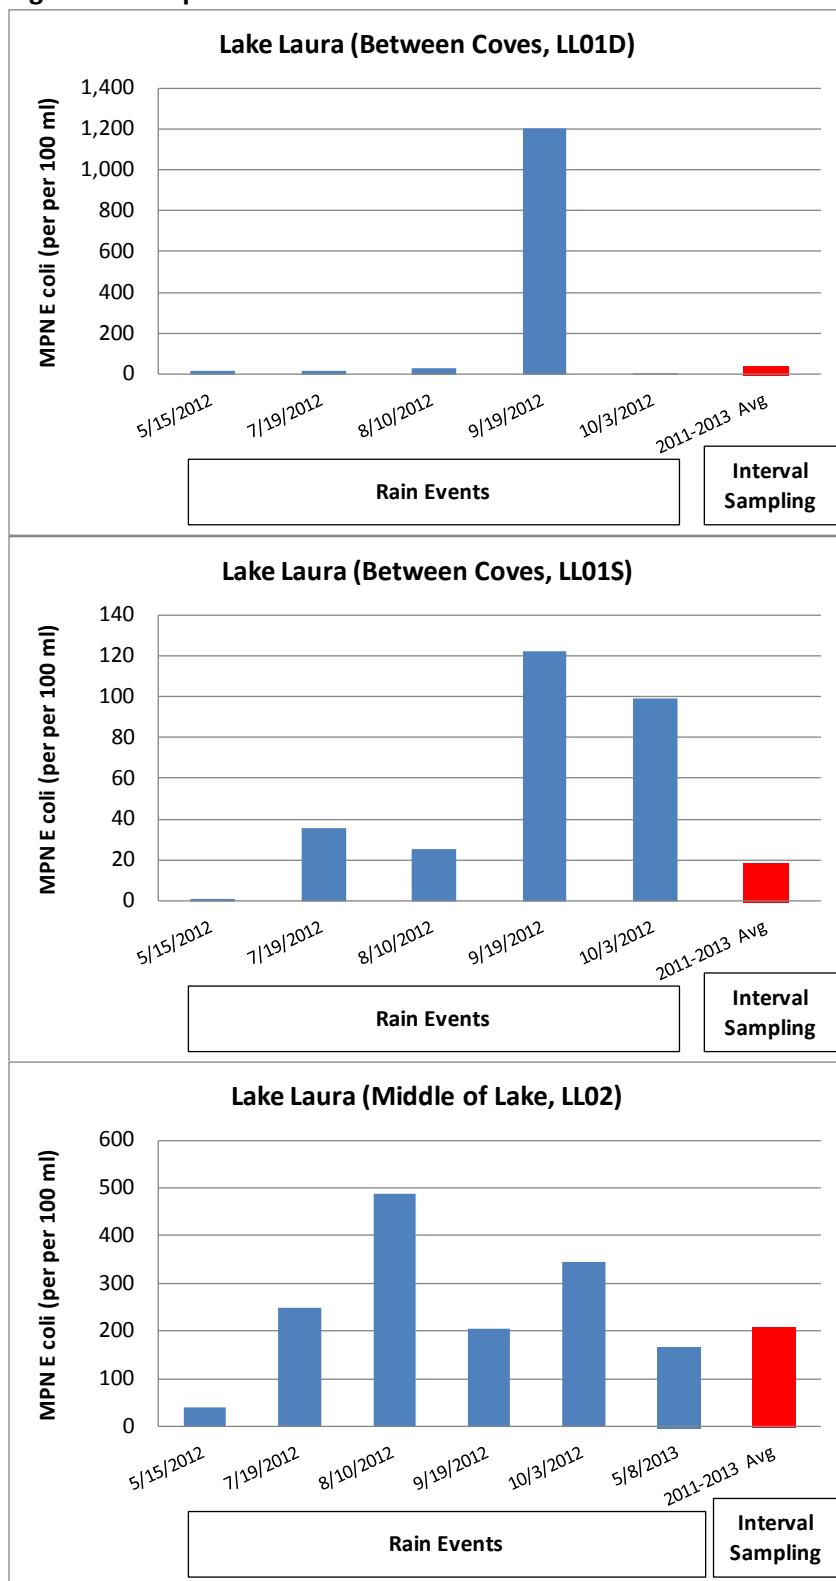
Figure 4-3 shows the E. coli levels in Lake Laura during the rain events in comparison to the 2011-2013 average levels determined through the periodic interval sampling. Individual rain events can greatly elevate E. coli levels in the lake, although our data do not indicate that every rain event elevates the levels above the long-term average observed in the interval sampling (shown in red at the right). This may be because of the timing of our sampling.

Figure 4-3. Impact of Rain Events on E. coli Levels in Lake Laura

- The LL01D measurements are deep samples taken 5 meters below the surface at a location between the coves. At this depth, only the 9/19/2012 rain elevated E. coli above the long-term average while the other four events did not cause elevated levels.
- The LL01S measurements are taken at the same location as LL01D, but at the usual depth of 1 meter below the surface. At this depth, four of the five rain events in 2012 had elevated E. coli above the long-term average.
- At LL02 (in the middle of the lake, also at 1 meter below the surface), E. coli levels were above the long-term average for three events, below (but close to) the average for two events, and well below the average for one event.

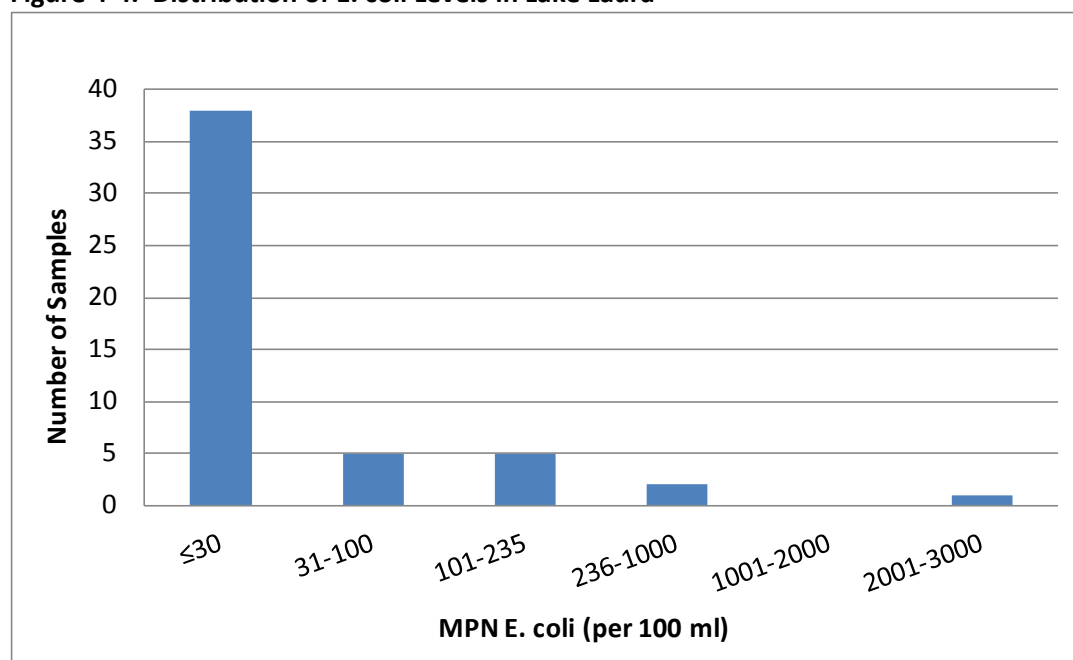
Figure 4-4 shows the distribution of *E. coli* levels recorded in the lake during the 2011-2013 interval sampling. For 75 percent of the samples, measured *E. coli* levels were less than or equal to 30 MPN¹⁰ per 100 ml. For 10 percent of samples, *E. coli* levels were between 31 and 100 MPN per ml and levels were between 101 and 235 MPN per 100 ml for another 10 percent. For 6 percent of samples, *E. coli* levels were above the maximum standard of 235 MPN per 100 ml level for fresh water. Thus, *E. coli* levels in Lake Laura are low most of the time, but become elevated on an episodic basis. These episodes are most likely rain events in which runoff carries *E. coli* into the lake.

Figure 4-4. Distribution of *E. coli* Levels in Lake Laura

Based on these data, one can reasonably assume that *E. coli* levels will be elevated at one or more locations in the lake after rain events. The elevation is “temporary” but we have no time series data to show the rise and fall in *E. coli* over time that results from a rain event. However, we can note that when we first observed a high *E. coli* level in the lake in 2011, we re-sampled ten days later and found the *E. coli* levels to be much lower.

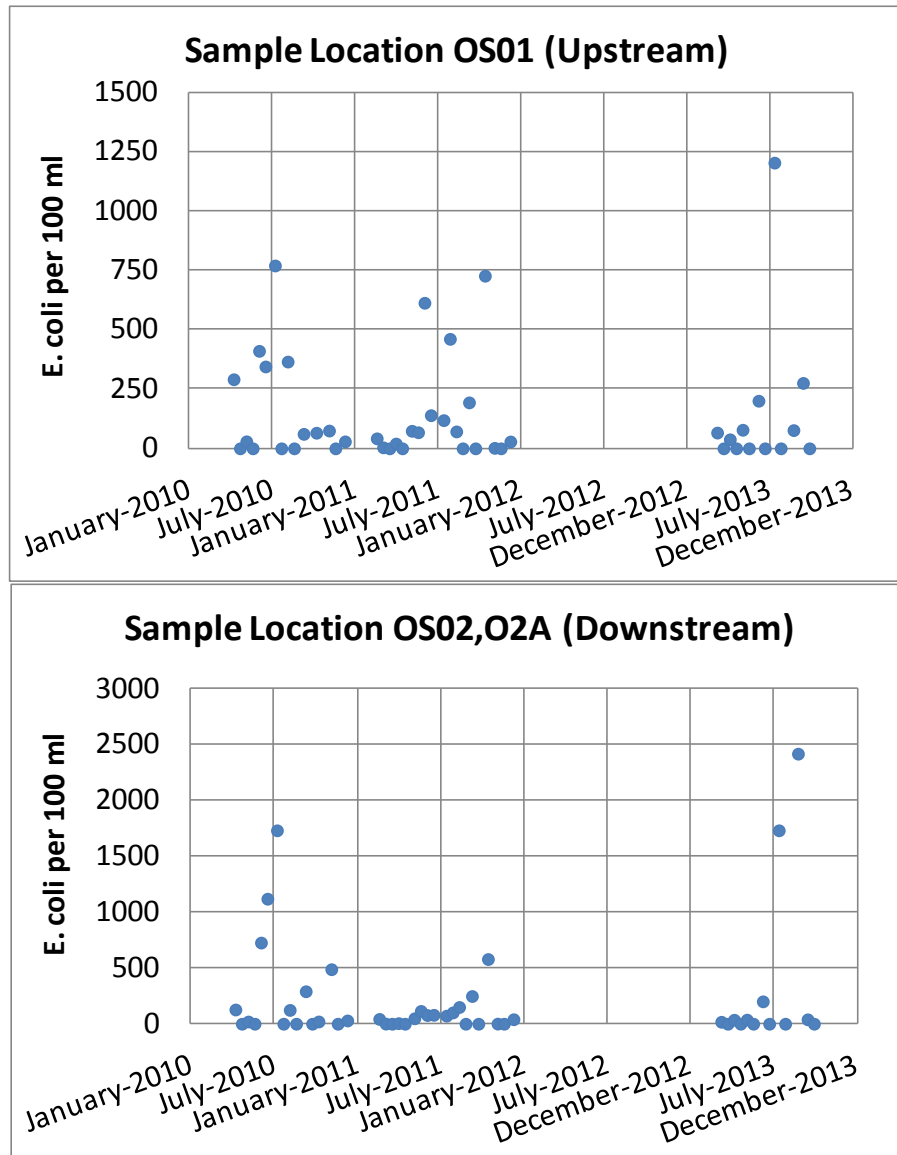
E. coli

Supporting Graphs: Water Quality Data for Sampling Points Above and Below the Discharge Point for the Orkney Springs Wastewater Treatment Plant.
